Annexure – VIII

8.0 Dust and Water Ingress Protection Test (IP67) as per IEC 60529:

8.3 Test Setup Photographs:

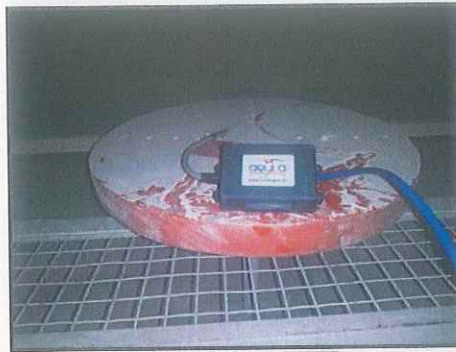
During Dust Test

a) **For Dust: No dust ingress was observed after the test.**
Result:
Before Test:
 \$iTriangle,CLIENT_1NS,TSOR1_TEST5,IN,L,861693034581413,KA-01 I-2000,1,030517151633,28.358704,N,76.927956,E,0,144,9,218.90,0.94,0, IDEA CELLULAR Ltd,1,1,0,C,20,404,04,019c,1e98,1e97,019c,e60b,019c,d843,019c,d77a,019c,0,0,0,0,0,0,000014,0,5B,*
After Test:
 \$iTriangle,CLIENT_1NS,TSOR1_TEST5,IN,L,861693034581413,KA-01 I-2000,1,040517104140,28.358883,N,76.928001,E,0,194,7,255.70,1.27,0, IDEA CELLULAR Ltd,1,1,0,O,19,404,04,0138,1c2b,1e98,019c,e60b,019c,1e97,019c,1c2c,0138,0,0,0,0,0,0,000027,0,0F,*
Satisfactory.

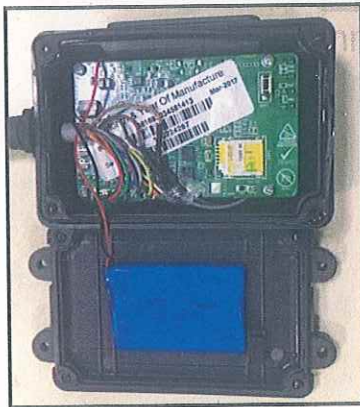
After Water Test

b) **For Water: No water ingress was observed after the test.**
Result:
Before Test:
 \$iTriangle,CLIENT_1NS,TSOR1_TEST5,IF,L,861693034581413,KA-01 I-2000,1,020517152419,28.358747,N,76.928154,E,0,100,10,246.40,0.82,0, IDEA CELLULAR Ltd,0,1,0,C,19,404,04,019c,1e98,e60b,019c,d843,019c,9ae3,019c,1c2c,0138,0,0,0,0,0,0,0000222,0,6F,*
After Test:
 \$iTriangle,CLIENT_1NS,TSOR1_TEST5,IF,L,861693034581413,KA-01 I-2000,1,020517162710,28.358829,N,76.928085,E,0,322,8,232.50,0.94,0, IDEA CELLULAR Ltd,0,0,0,O,18,404,04,019c,e60b,1e98,019c,1e97,019c,1c2d,0138,1eca,0138,0,0,0,0,0,0,000028,0,59,*
Satisfactory.

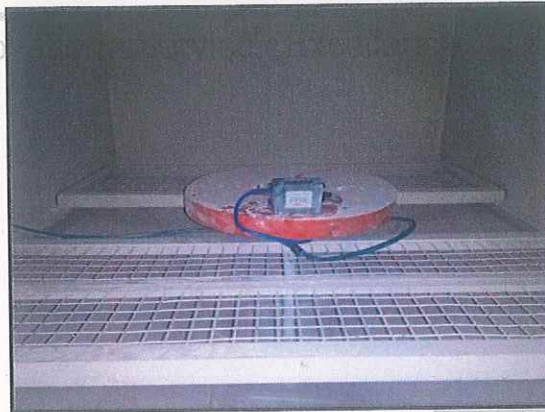
After Dust Test
